Irregular TRAILER TIRE Conditions

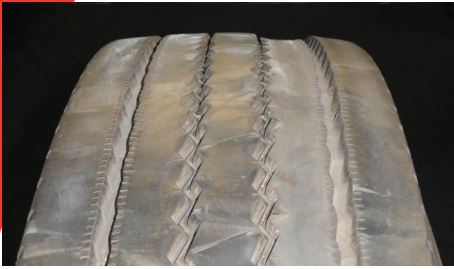
Depression Wear
(Intermediate)

Appearance	One or more interior ribs (not center) worn below adjacent ribs around the tire's circumference.
Probable Cause	Worn suspension components, mismatched dual diameter or inflation pressures, under-inflation, improper bearing adjustment. Aggravated by high speed/light loads.
Corrective Action	Diagnose mechanical condition and correct.
Tire Disposition	Continue to run until pull point, then retread.

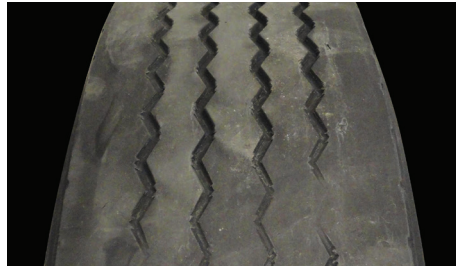
Diagonal Wear

Appearance	Localized flat spots worn diagonally across the tread, often repeating around the tire.
Probable Cause	Improper bearing adjustment, misalignment, mismatched dual tire diameter and/or inflation pressure. May start as brake skid. Aggravated by high speed/light loads.
Corrective Action	Analyze cause and correct.
Tire Disposition	Reverse direction of rotation. If excessive, submit for retreading.

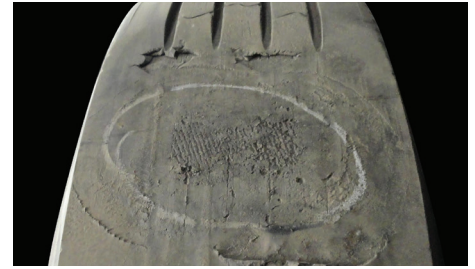
Brake Skid Damage

Appearance	Localized spot of excessive wear across tread face showing abrasion marks. Damage may extend into casing.
Probable Cause	New brakes (not worn in), unbalanced brake system, frozen brake lines, driver abuse.
Corrective Action	Check brake system.
Tire Disposition	May be repaired or retreaded if casing is undamaged; otherwise, scrap.

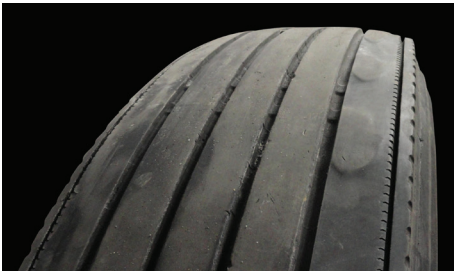
Depression Wear
(Shoulder)

Appearance	Localized areas of wear in shoulder, generally less than 12" in length.
Probable Cause	Improper inflation pressure or tire mismatched on wheel. Can also be caused by some other type of wheel end imbalance.
Corrective Action	Review tire and wheel end maintenance practices.
Tire Disposition	Continue to run until pull point, then retread.

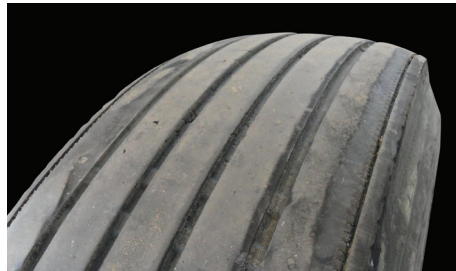
Shoulder Step Wear

Appearance	Tire worn on edge of one shoulder, greater than 12" in circumference.
Probable Cause	Excessive camber, misaligned or damaged axle, improper bearing adjustment.
Corrective Action	Diagnose misalignment and/or mechanical condition and correct.
Tire Disposition	Reverse direction of rotation. If excessive, submit for retreading.

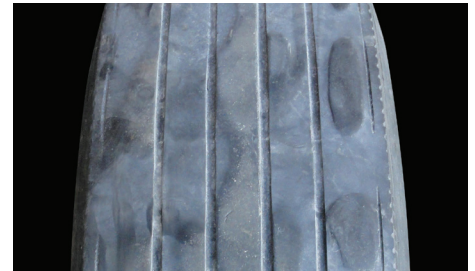
Cupping / Scallop Wear

Appearance	Random areas of fast wear around the tire. Erratic in some instances.
Probable Cause	Mismatched inflation pressure or tire diameters in a dual assembly. Aggravated by high speeds/light loads, poorly maintained suspension components.
Corrective Action	Check for worn components, inflation pressures and matching tread depths.
Tire Disposition	Continue to run until pull point, then retread.
