THE USUAL SUSPECTS

Irregular Drive Tire Conditions

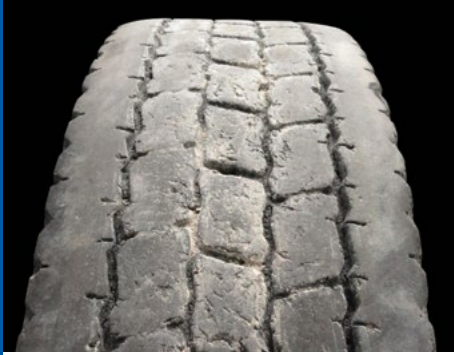
Multiple Cuts/Chunking

Appearance	Numerous small cuts to the tread surface with portions of tread removed, giving a rough appearance.
Probable Cause	Vehicle operation on rough surfaces (misapplication of tread compound).
Corrective Action	Review tire selection and operation.
Tire Disposition	Minor damage should return to service. Consult retreader for possible repair and retread.

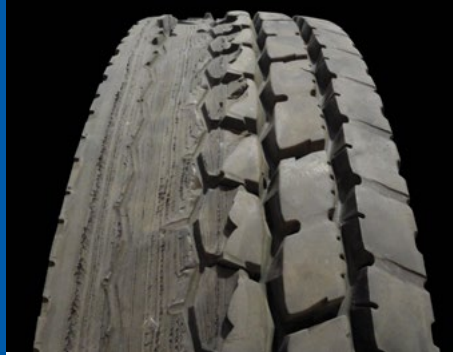
Vehicle/Spin Damage

Appearance	Cuts or lines 360 degrees around the tire.
Probable Cause	Contact with vehicle components (mud flap brackets, bumpers), or spinning the tires on ice or loose road surface.
Corrective Action	Analyze cause. Ensure tire does not contact vehicle components. Review driver practices.
Tire Disposition	Return to service if damage is not below base of tread groove. If deeper, retread or scrap.

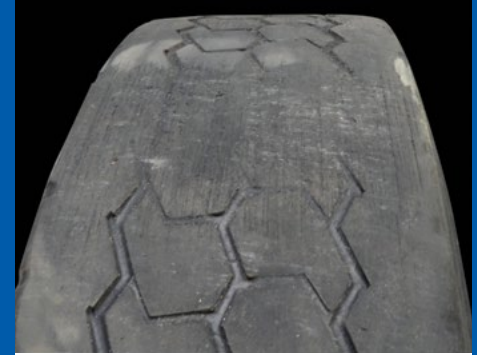
Brake Skid Damage

Appearance	Localized spot of excessive wear across tread face showing abrasion marks. Damage may extend into casing.
Probable Cause	New brakes (not worn in), unbalanced brake system, frozen brake lines, driver abuse.
Corrective Action	Check brake system.
Tire Disposition	May be repaired or retreaded if casing is undamaged; otherwise, scrap.

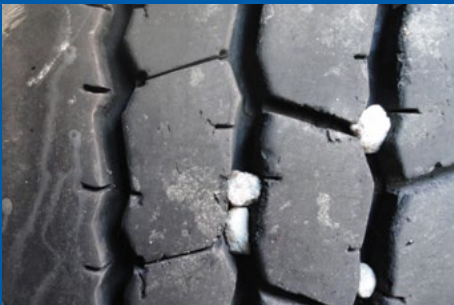
Stone Retention/Drilling

Appearance	Stones or gravel imbedded between tread blocks, sometimes reaching steel cables.
Probable Cause	Condition is common with vehicles operating on gravel surfaces. Overinflation, misapplication of the tire.
Corrective Action	Remove stones & return to service. Maintain proper inflation pressures.
Tire Disposition	Continue to run unless there are multiple spots reaching steel cables. Consult retreader or tire manufacturer.

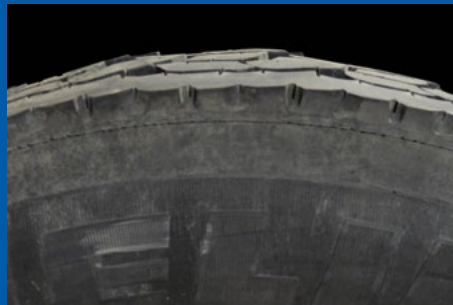
Heel/Toe Wear

Appearance	Each lug around tire worn high to low from front to back edge.
Probable Cause	Mismatched inflation pressure or tire diameters in a dual assembly. High torque conditions, mountainous terrains, and high inflation pressures aggravate this condition.
Corrective Action	Review tire maintenance practices. Consult tire manufacturer when selecting tire for operation.
Tire Disposition	Continue to run. If severe, change direction of rotation.

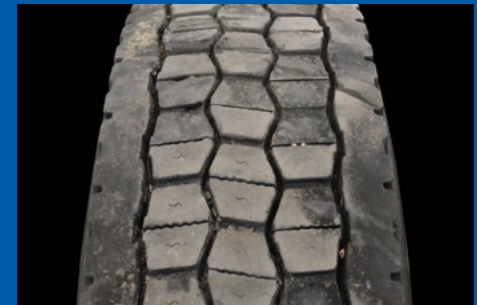
Cupping/Scallop/Alternate Lug Wear

Appearance	Localized cupped-out areas of fast wear around the tire. Alternate lugs worn to different tread depths around the tire.
Probable Cause	Mismatched inflation pressure or tire diameters in a dual assembly. Aggravated by slow rate of wear, poorly maintained suspension components.
Corrective Action	Check for mechanical problem.
Tire Disposition	Check for worn components, inflation pressures and matching tread depths.
